**DEPARTMENT OF TRANSPORTATION**

Contract #: 04-0120F4Cty: SF/ALA Rte: 80 PM: 13.2/13.9File #: 1.28**WELDING INSPECTION REPORT****Resident Engineer:** Casey, William**Address:** 333 Burma Road**City:** Oakland, CA 94607**Report No:** WIR-028848**Date Inspected:** 09-Dec-2012**Project Name:** SAS Superstructure**OSM Arrival Time:** 700**Prime Contractor:** American Bridge/Fluor Enterprises, a JV**OSM Departure Time:** 1530**Contractor:** American Bridge/Fluor Enterprises, a JV**Location:** Job Site**CWI Name:** See below.**CWI Present:** Yes No**Inspected CWI report:** Yes No N/A**Rod Oven in Use:** Yes No N/A**Electrode to specification:** Yes No N/A**Weld Procedures Followed:** Yes No N/A**Qualified Welders:** Yes No N/A**Verified Joint Fit-up:** Yes No N/A**Approved Drawings:** Yes No N/A**Approved WPS:** Yes No N/A**Delayed / Cancelled:** Yes No N/A**Bridge No:** 34-0006**Component:** OBG**Summary of Items Observed:**

## WELDING INSPECTION REPORT

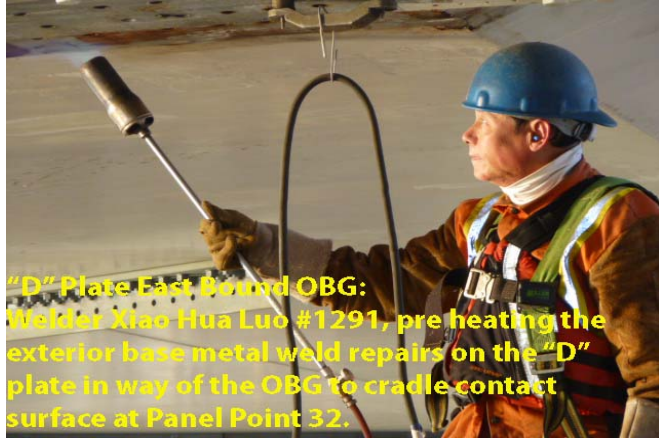
**"D" Plate East Behind OBG:**  
Welder Xiao Hua Luo #1291, pre heating the exterior base metal weld repairs on the "D" plate in way of the OBG to cradle contact surface at Panel Point 32.

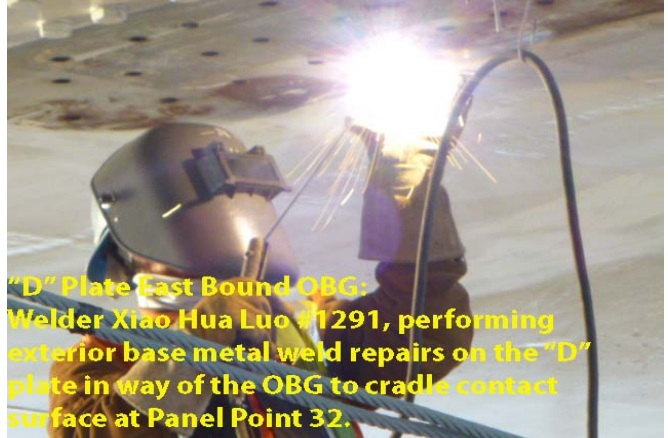
**"D" Plate East Bound OBG:**  
Welder Xiao Hua Luo #1291, performing exterior base metal weld repairs on the "D" plate in way of the OBG to cradle contact surface at Panel Point 32.
